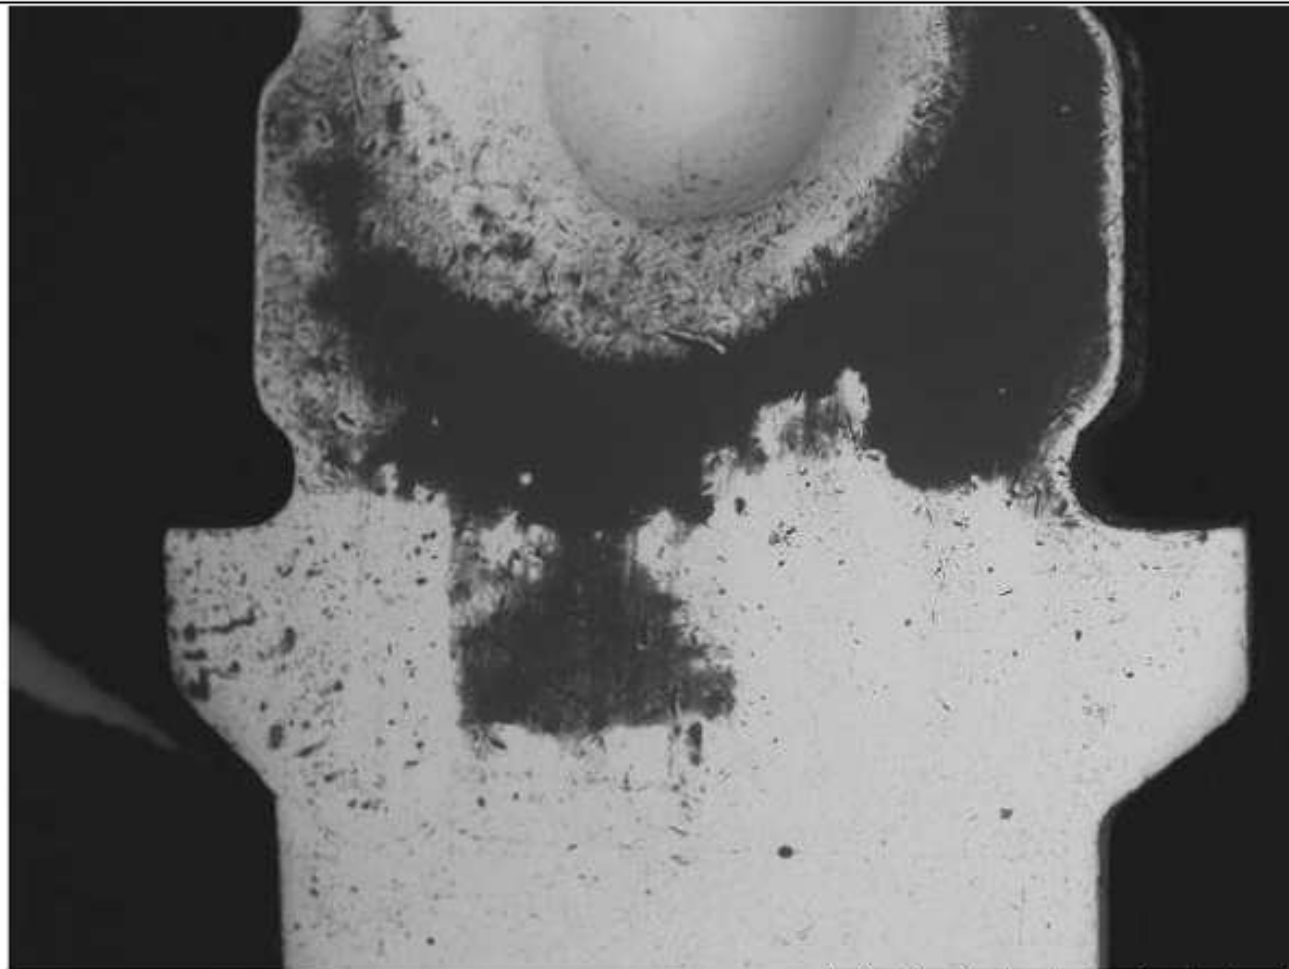
Fig.25: SEM image in the middle of the copper carrier

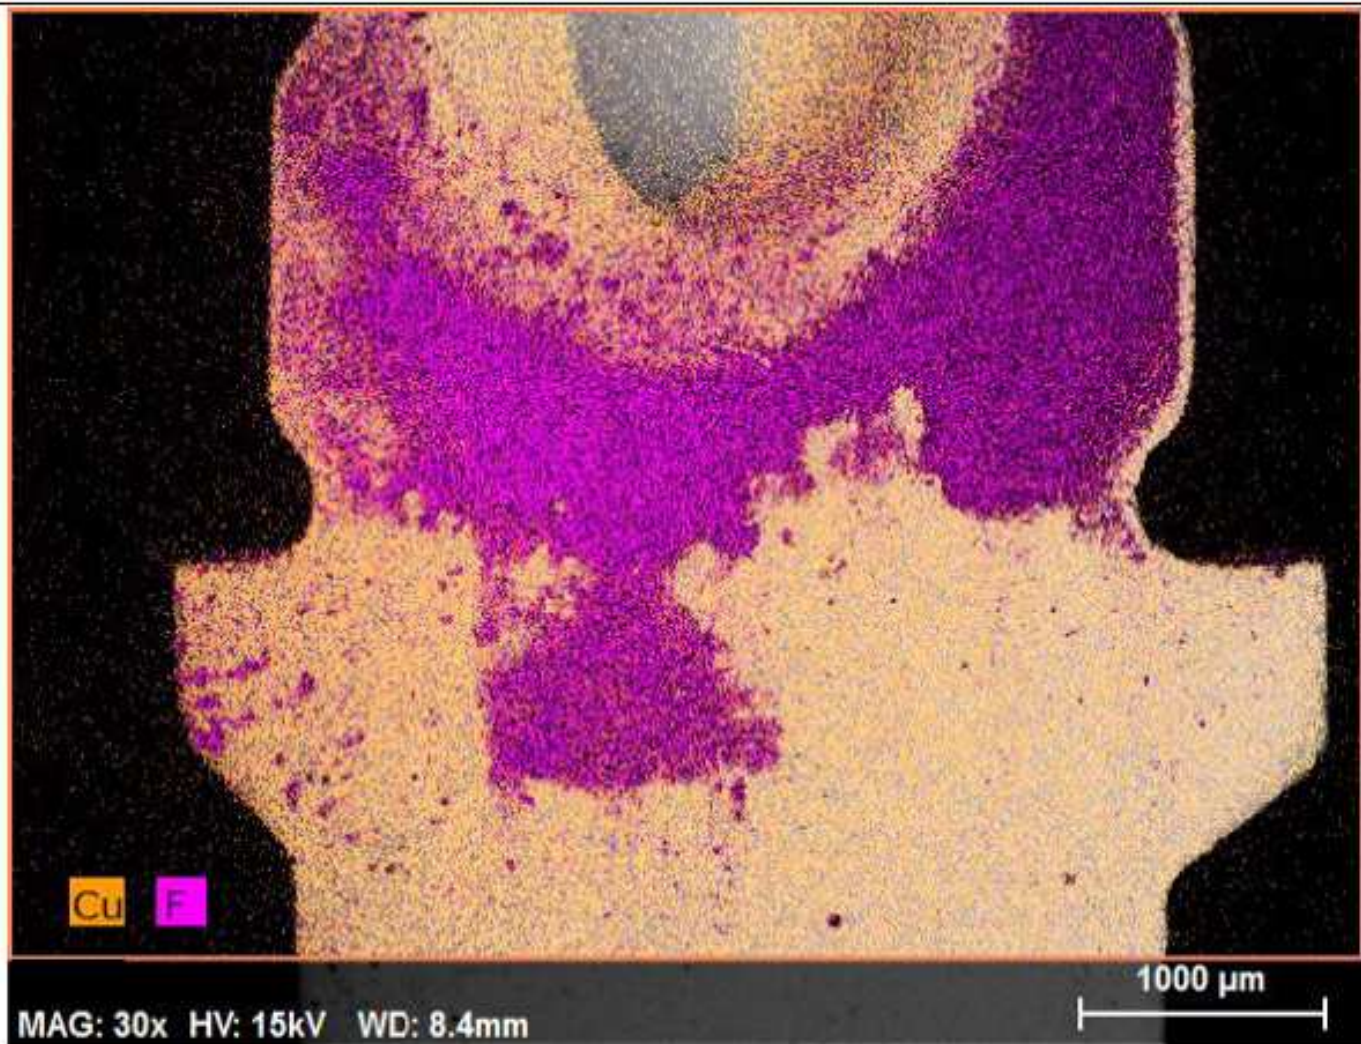
Fig. 26: EDX mapping in the middle of the copper carrier. Fluorine is clearly detected
